Civilian Conservation Corps Serpentine Walls

Introduction

The Serpentine Walls are two long sinuous erosion control structures built in the 1930s by the Civilian Conservation Corps (CCC) in Tucson Mountain Park (TMP). Today the Serpentine Walls are located within Saguaro National Park's Tucson Mountain District (TMD).

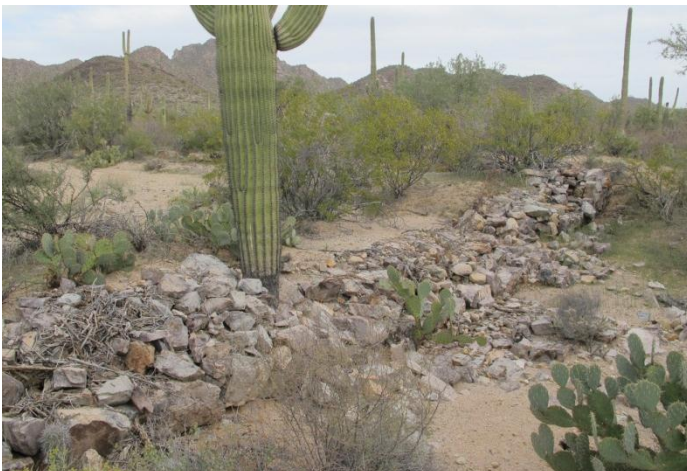
One of two Gabion style dams along the East Serpentine Wall.

stone facing on the upslope side. The east wall has two Gabion style dams constructed of rock and wire mesh. This style of dam is sometimes referred to as sausage dams by the CCC. These two dams span large drainages. One of the dams is 42 feet long; the other is 60 feet long; both are about 3 feet high. Both dams have a rock apron along their center on the downslope side. These aprons help prevent erosion caused by water running over the tops of the dams. A similar apron can be seen along the base of the large CCC dam at Sus Picnic Area. Neither of the Serpentine Wall dams is functional. Erosion has cut around the south end of one dam; the other has partially collapsed at the center.

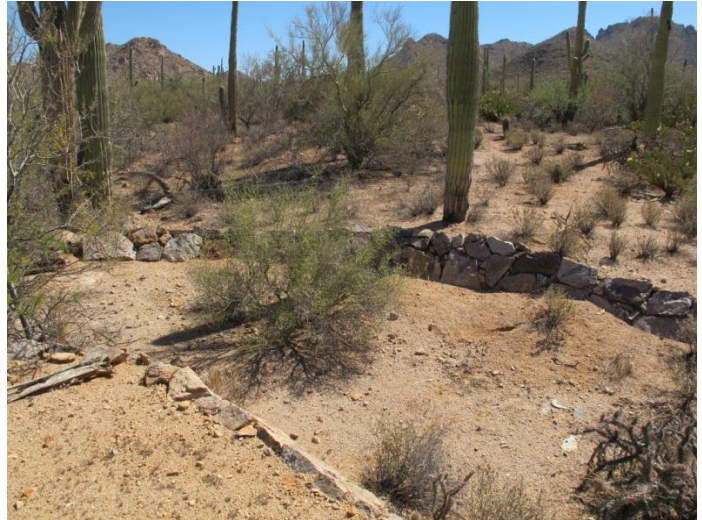
One of the stone-lined spillways. This one is Feature 2 (see map) on the north end of the West Serpentine Wall.

At the ends of both walls and at other locations along the walls are stone-lined spillways. These spillways are about 100 feet long by 20 feet in width. The sides of the spillways consist of large stacked, unmortared rock and are battered (angled back). Floors of the spillways consist of large flat laying rock pavement. At the terminal end of each spillway is a pavement of small crushed rock.
